Technical Report

DEVELOPMENT OF COST-EFFECTIVE MANUFACTURING PROCESS FOR PRODUCING CERAMIC TURBOCHARGER ROTORS

AUGUST, 1987

No. 13270

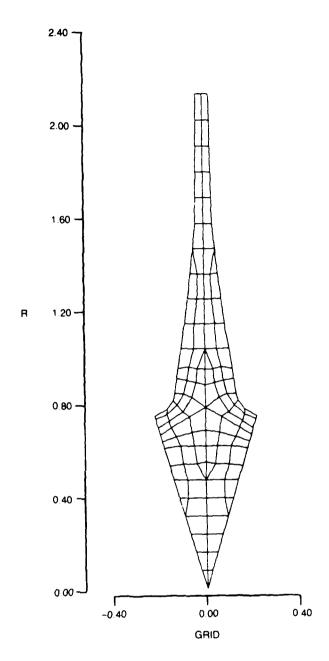
Figure 5-6. Grid for Radial Model

The stresses in the blade and blade fillet area are best modeled in a two-dimensional section by a plane section perpendicular to the axis of rotation. This model consists of 104 elements and 130 nodes as shown in Figure 5-6. The plot of maximum principal stress is shown in Figure 5-7. Analysis of this plane section shows a 30-percent reduction in peak stress at the blade root from the original design. No effects of blade bending were modeled in this section.

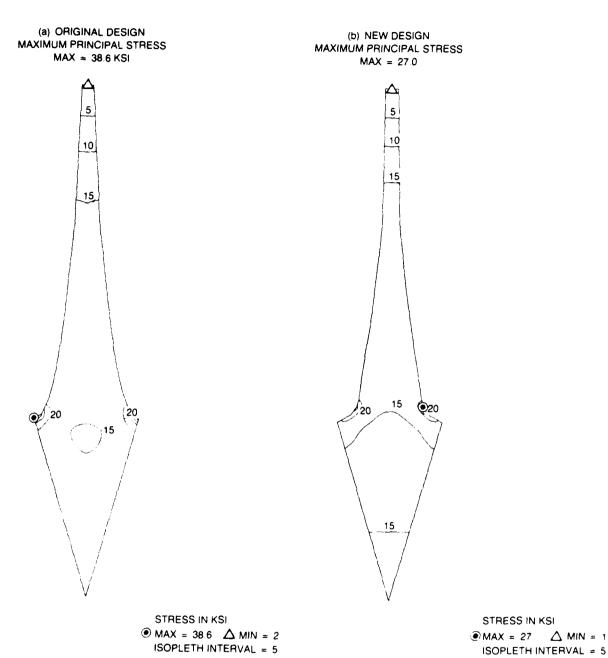
Figure 5-7. Maximum Principal Stresses

STRESS IN KSI

ISOPLETH INTERVAL = 5

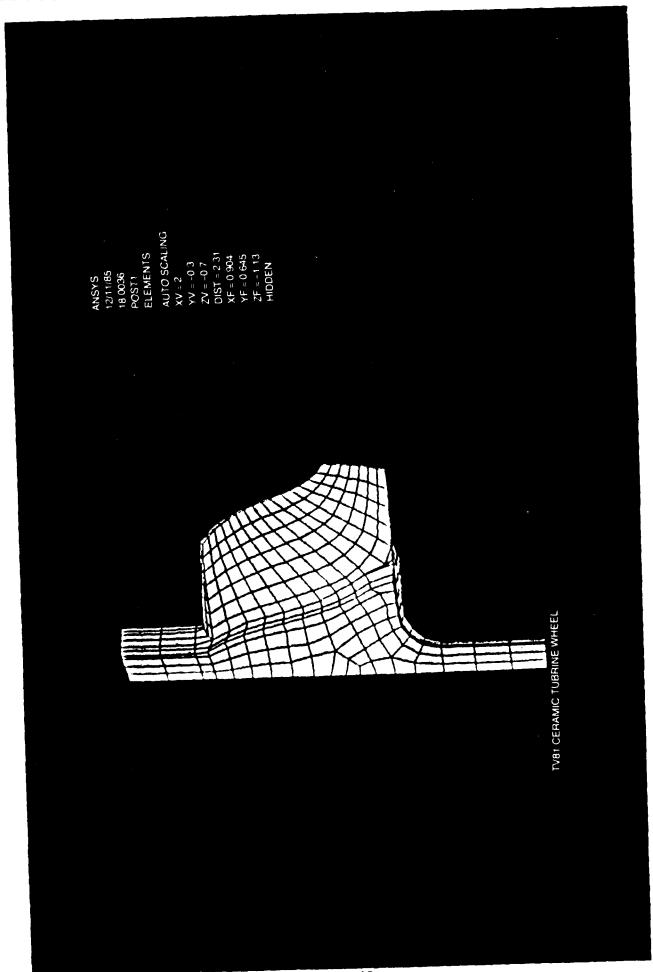
Cathode Ray Tube (CRT) Display of Three-Dimensional (3-D) Model F13488 5-8.

The analysis has also been done using the ANSYS program. The conditions of the analysis are for uniform temperature of 21 $^{\circ}$ C (70 $^{\circ}$ F) and a turbocharger speed of 80,000 r/min. Also included in the analysis is the compressive pressure on the shaft from the shrink fit of the shaft attachment. No aerodynamic loads are imposed on the blades.

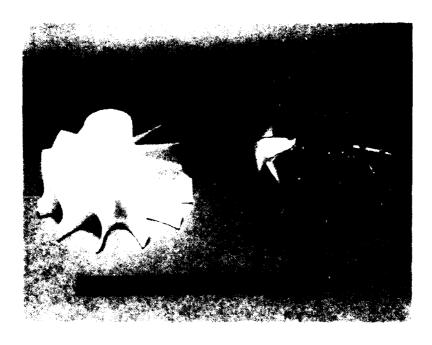
Figure 5-14. Revised TACOM Injection Wax Pattern (Left), Complete TACOM Wax Shell (Right)

In the meantime, wax and plaster mold preparation can take place. Using the TACOM rotor as the example, the actual rotor fabrication begins with the injection of water-soluble wax into patterns (Figure 5-14 left). From soluble wax injection, the wax pattern is assembled onto a tooling fixture and dipped in an insoluble wax (see Figure 5-15). The wax assembly is machined to trim off excess wax and to allow the wax shell to fit properly onto a plaster. Once machined, the wax pattern (see Figure 5-14, right) is soaked in water to completely dissolve the soluble wax pattern. The wax shell is then mounted onto a plaster (Figure 5-16) designed specifically for the machined wax shell. An alignment fixture (see Figure 5-17) is used to hold the shell in place on the plaster, allowing the symmetry of the rotor (formed by the wax shell) and the rotor shaft (formed by the plaster) to be maintained (Figure 5-18 shows assembled mold).

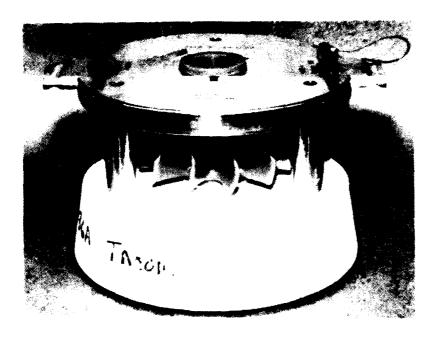
Figure 5-18. Complete TACOM Mold Assembly

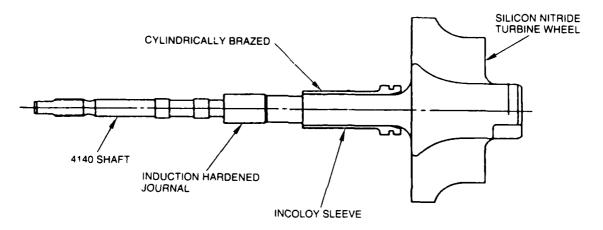
Figure 5-21. Ceramic Shaft Wheel Assembly

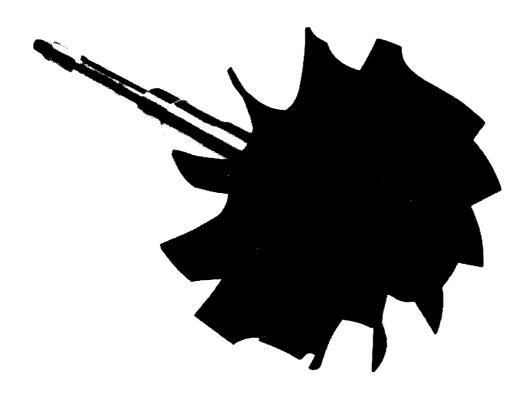
Figure 5-22. TACOM TV81 Ceramic Shaft Wheel Assembly

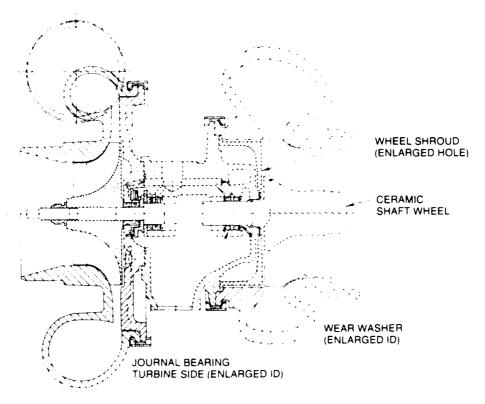
Figure 5-24. Design Modifications to Accommodate Ceramic Shaft Wheel in TV81

5.2.9. Turbocharger Design Modifications. Only three parts of the turbocharger assembly required modification to accept the ceramic turbine wheel. Those parts are the turbine side journal bearing, the turbine side bearing wear washer and the wheel shroud. See Figure 5-24.

The standard TV81 journal bearing inside diameter was enlarged from .6272/.6268 inches to .7018/.7014 inches to fit the larger diameter shaft wheel assembly. The same shaft-to-bearing clearance was maintained.

Enlarging the inside diameter of wear washer P/N 407135 from .650/.670 inches to .730/.750 inches gives the necessary clearance for use against the turbine side bearing.

The ceramic turbine wheel has a much larger blend radius from the wheel back-disc to the stub shaft than the same feature on the metal wheel, plus the ceramic shaft is larger in diameter in this same area. These differences cause an interference between the wheel and the shroud. To correct this problem, the size of the hole in the shroud was enlarged from .860/.865 inches to 1.000/1.005 inches.

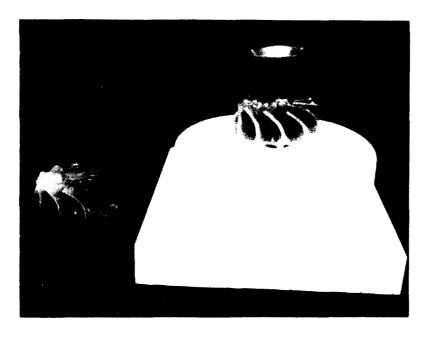
Figure 5-26. TV8117 Injection Wax Pattern (Left), TV8117 Wax Shell/Plaster Assembly (Right)

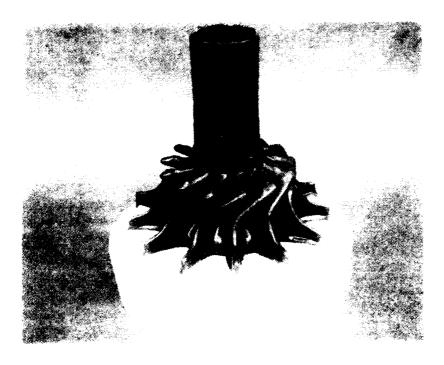
Figure 5-33. AGT-101 Mold Assembly

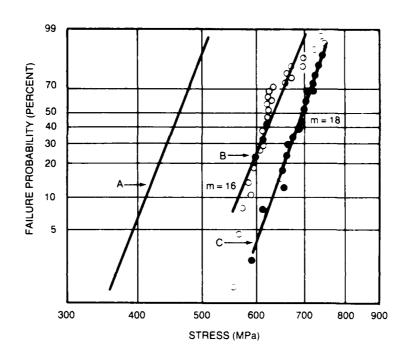
Figure 5-34. Failure Probabilities of Silicon Nitride (Kyocera SN 220M)

Today, the relationship between the strength of test specimens and strength, life and failure probability of actual ceramic components can be formulated by fracture mechanics and Weibull statistics. Figure 5-34 shows the Weibull distribution of the fracture stress of silicon nitride test specimens which were dry pressed and sintered in the shape of small bars as well as specimens which were cut from turbine wheel hubs made by slip casting and sintering the same material.

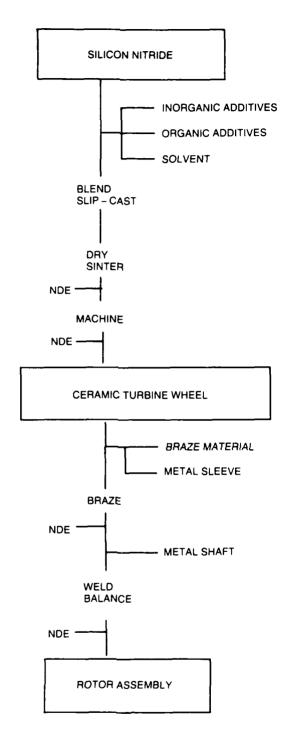
Figure 5-35. Process Flow Diagram for Ceramic Turbine Wheels and Rotor Assemblies

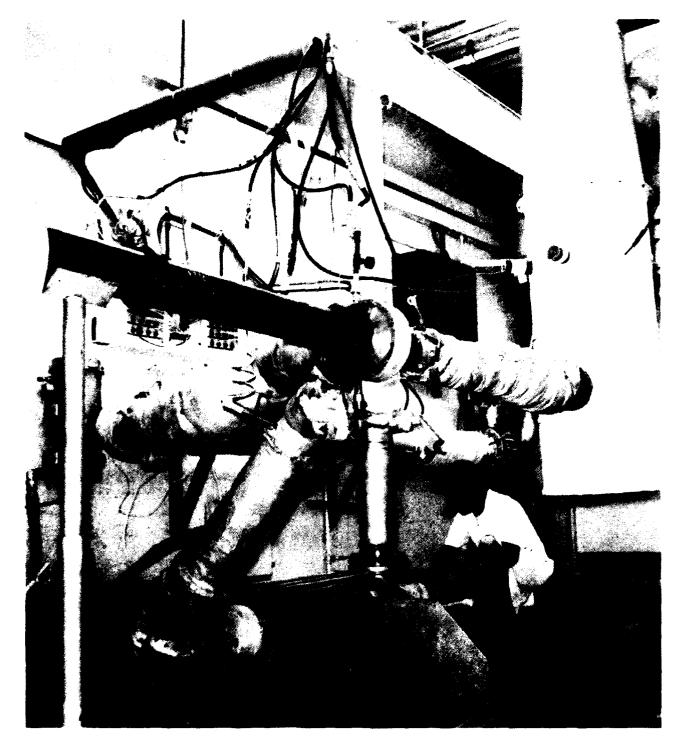
Figure 5-36. Turbocharger Test Setup

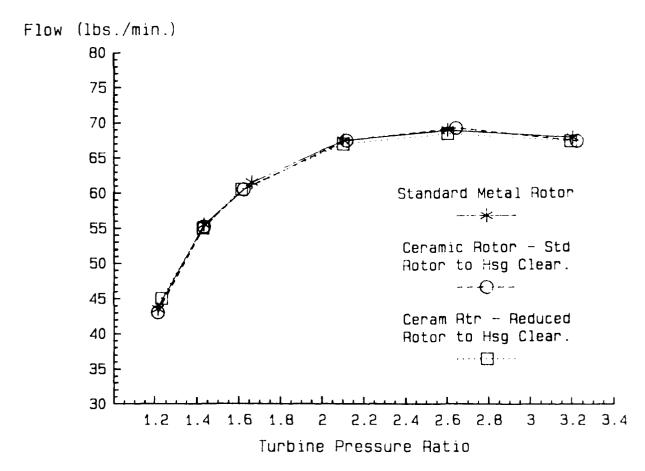
Figure 5-37. TACOM-TV81 Ceramic vs. Metal Rotor Turbine Performance

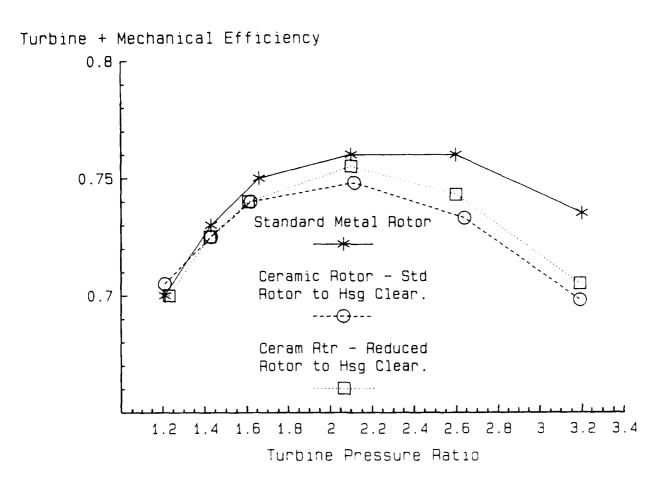
Figure 5-38. TACOM-TV81 Ceramic vs. Metal Rotor Turbine Performance

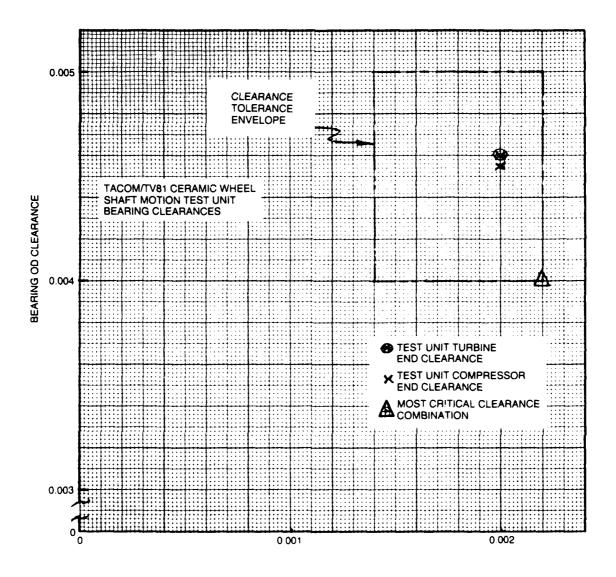
Figure 5-41. TACOM/TV81 Ceramic Wheel Shaft Motion Test Unit Bearing Clearances

For the shaft motion test, one unit (S/N TAC 008) was randomly selected from the group of test and shipping units. Certain critical measurements made on this unit are listed in the Appendix. The bearing clearances are graphically shown in relation to the total tolerance range of clearances on Figure 5-41. The bearing clearances of this unit are close to mean value clearances. The

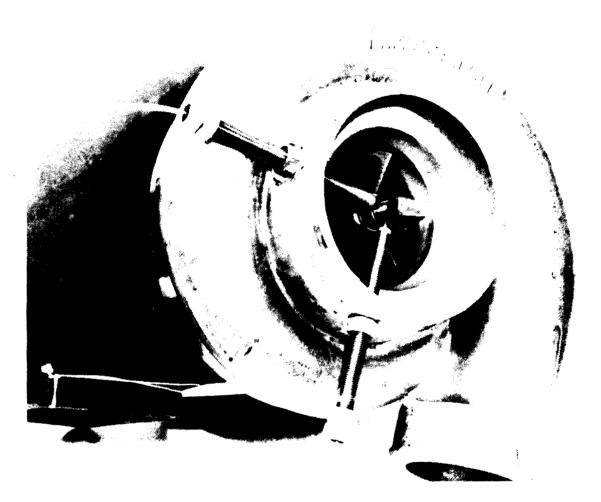
Figure 5-42. Compressor Inlet with Proximity Probes

Shaft motion characteristics are determined by measuring the dynamic excursions of the rotating assembly outboard of the compressor wheel. Proximity probes located 90 apart provide X-Y shaft position data and with appropriate readout instrumentation, the output can be formatted to show orbital characteristics, spectral frequency analysis and total excursion as a function of rotational speed. The initial tests were scans across the operational speed range to establish worst-case conditions. Orbital and frequency analyses were made at conditions where peaks, spikes or other unusual conditions were revealed by the speed sweeps.

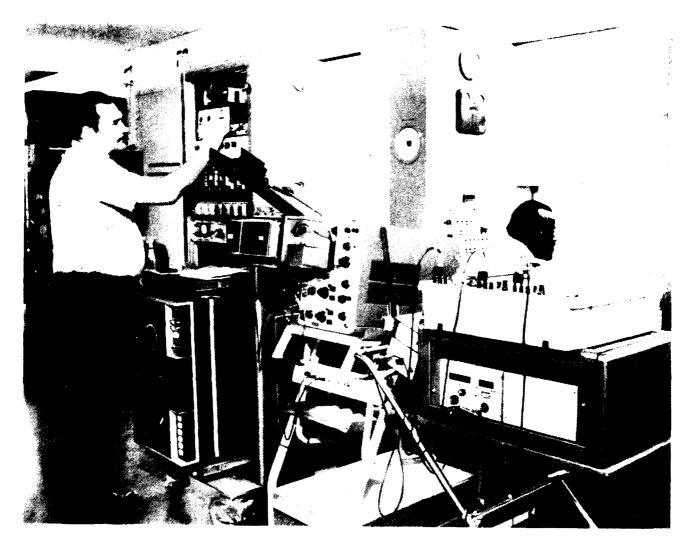
Figure 5-43. Instrumentation Setup for Shaft Motion Test

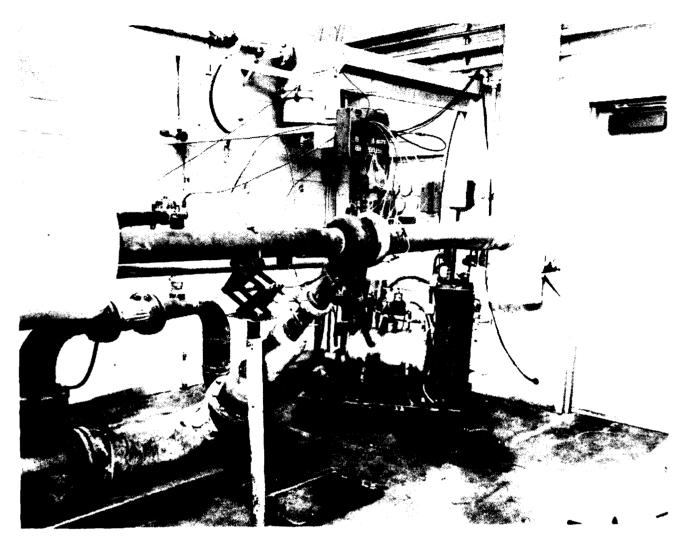
Figure 5-45. Boot Strap Gas Stand Test Setup

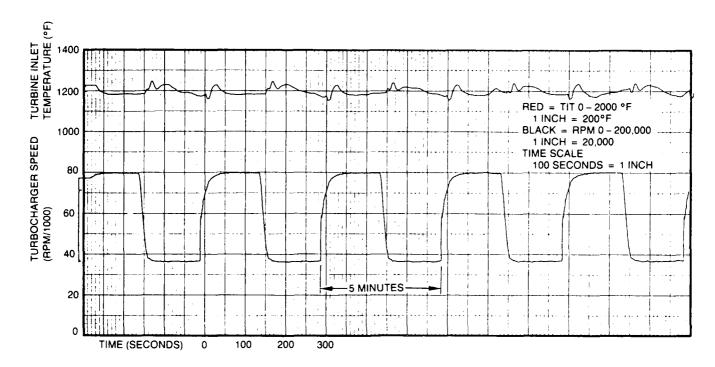
Figure 5-46. Durability Test Cycle

The laboratory test log sheets and a plotted trace of the actual cycle for each of the four units are shown in Appendix E. A typical cycle trace is shown in Figure 5-46.

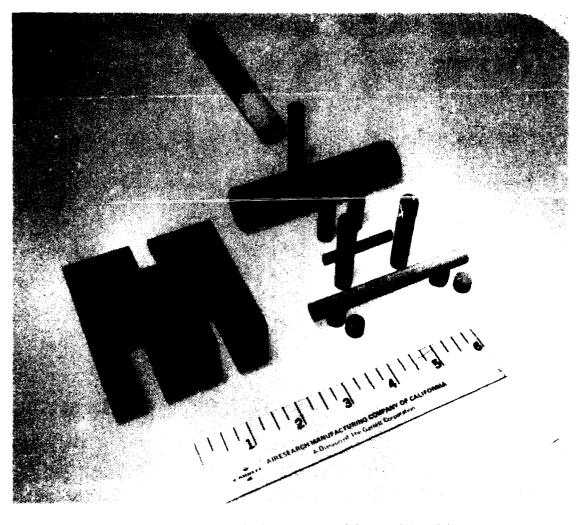
Figure 5-47. Hot/pressed Silicon Carbide Self-Aligning Fixture

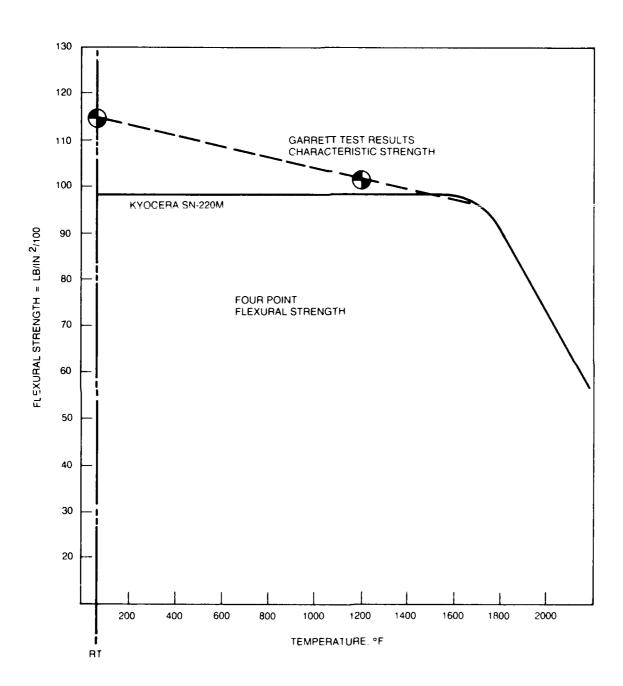
Figure 5-49. Four Point Flexural Strength

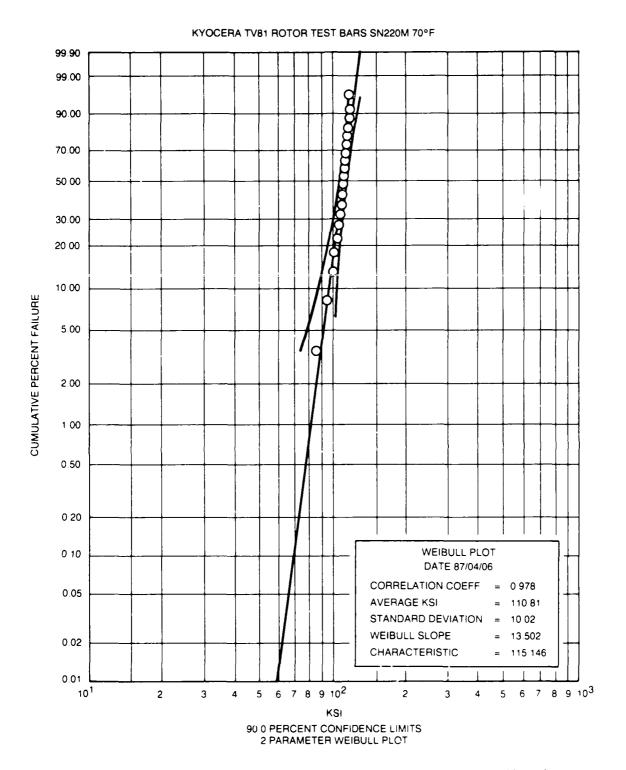
Figure 5-50. Four Point Bending Test Weibull Distribution ... Ambient Temperature (20 Specimen).

Ambient temperature testing of 20 specimens produced a characteristic strength of 115.1 Kips Per Square Inch (KPSI) and Weibull modulus of 13.5. At 649 C (1200 F), the group characteristic strength was 101.2 KPSI and modulus of 10.9. A tabulation of the test data points are presented in Appendix F. Kyocera published four point flexural strengths versus temperature are shown in Figure 5-49 with the two Garrett test points. Extrapolating the Garrett points upward with temperature tends to point to the knee in the Kyocera curve where in this temperature range, strengths normally decline. Figures 5-50 and 5-51 are corresponding two parameter Weibull plots depicting slope and failure distribution. The values obtained from this test are sufficient to exceed the predicted requirements to provide .1 percent failure at rated speed.

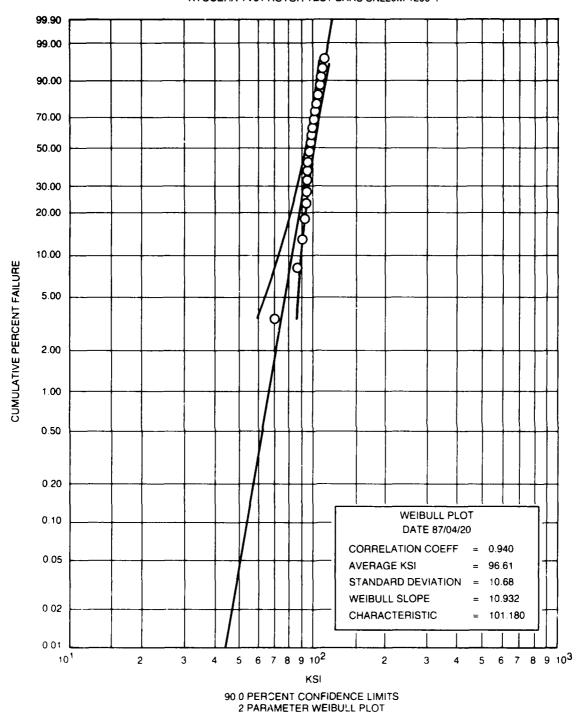
KYOCERA TV81 ROTOR TEST BARS SN220M 1200°F

Four Point Bending Test Weibull Distribution ... Elevated Temperature (20 Specimen)

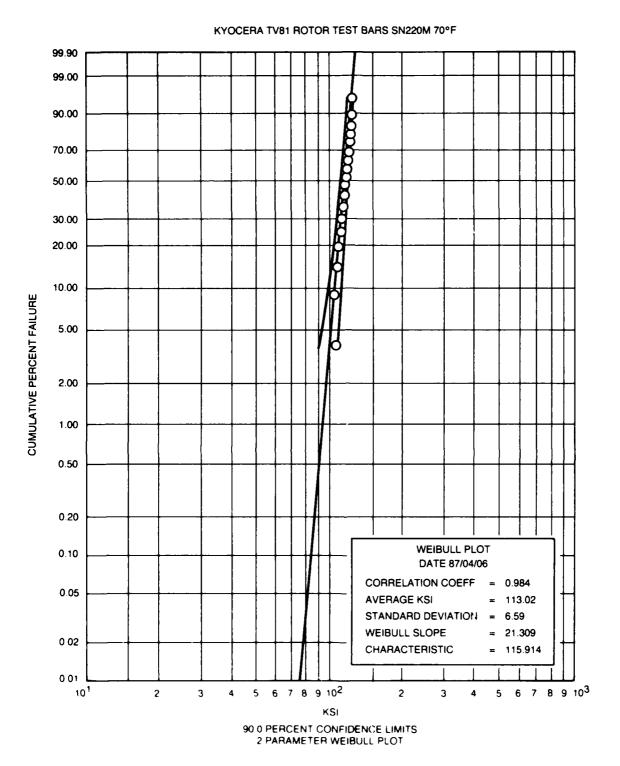
Figure 5-52. Four Point Bending Test Weibull Distribution ... Ambient Temperature (1) Specimen)

In each of the 2 groups of 20 specimens, one point seemed to fall low. The effect of these points on characteristic strength and Weibull modulus are shown on Figures 5-52 and 5-53. Ambient temperature characteristic strength was 115.9 KPSI and Weibull modulus of 21.3. At 649 $^{\circ}$ C (1200 $^{\circ}$ F), the characteristic strength was 101.3 KPSI and modulus of 15.9. Thus, neglecting the 1 low point in 20 has a lesser effect on strength, but a dramatic increase of Weibull modulus.

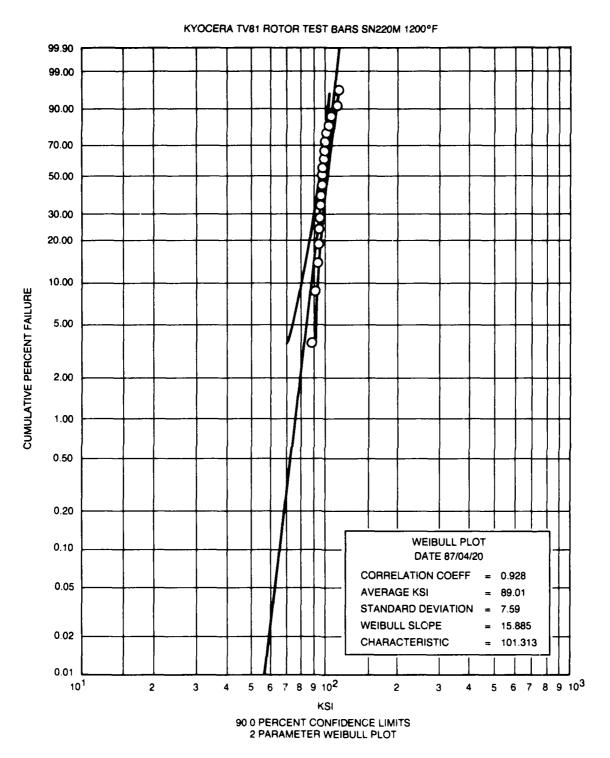
Figure 5-53. Four Point Bending Test Weibull Distribution ... Elevated Temperature (19 Specimen)
